Assessment of the Tertiary Irrigation System in Bulutimorang Irrigation Area, Sidrap Regency

ABSTRACT

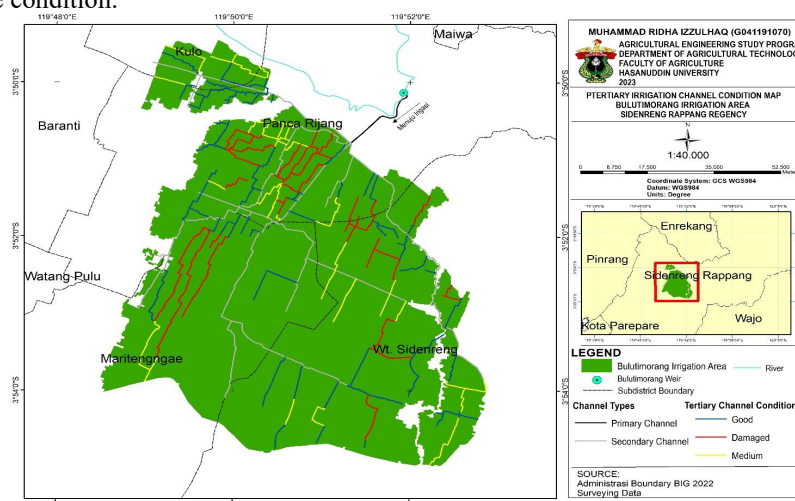
Figure 2. Tertiary Channel Condition Map of D.I. Bulutimorang.

The condition of the tertiary irrigation canals can be seen in Figure 2 where there are three conditions given to the tertiary irrigation canals, namely blue color for good condition, red color for damaged condition, and yellow color for moderate condition.
