Assessment of the Tertiary Irrigation System in Bulutimorang Irrigation Area, Sidrap Regency

Muhammad Ridha Izzulhaq^{*1}, Iqbal¹, and Mahmud Achmad¹, Fadhil Surur², and Husnul Mubarak¹

¹ Agriculture Engineering Study Program, Department of Agricultural Technology, Faculty of Agriculture, Hasanuddin University

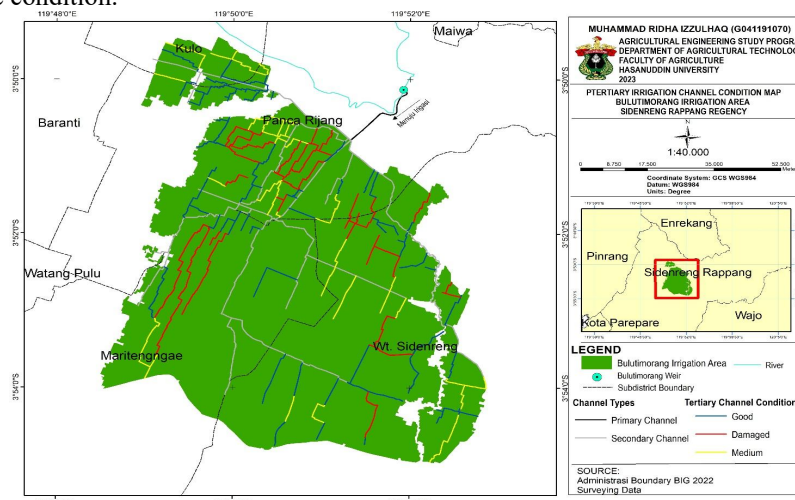
Figure 2. Tertiary Channel Condition Map of D.I. Bulutimorang.

The condition of the tertiary irrigation canals can be seen in Figure 2 where there are three conditions given to the tertiary irrigation canals, namely blue color for good condition, red color for damaged condition, and yellow color for moderate condition.
